Guidelines/Best Practices for Scraping PE Pipe and Fittings

In this project, researchers developed a functional set of improved, up-to-date guidelines for scraping PE pipe and fittings. The guidelines take into account current tooling and scraping practices while addressing the variables associated with fusion execution.

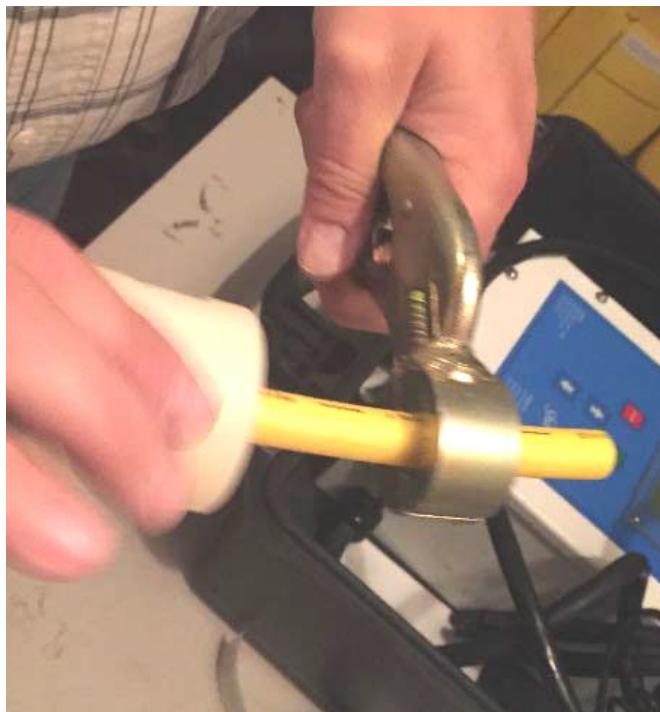
Testing of a pencil scraper on a 1/2-inch plastic tubing.

Oval pipe (up to ~5%) did not appear to adversely affect scraping depth. The test results showed that spring-loaded scrapers generally follow the outer diameter of the pipe and, therefore, appreciable re-rounding by scraping may or may not occur. The pencil scraper did consistently re-round the pipe due to its fixed blade and cavity. The influence of pipe ovality on electrofusion quality is directly related to the gap sensitivity of the fitting and the fitting's dimensional tolerances – therefore, sensitivity to ovality must be evaluated on a per-fitting basis.
