Guided Wave Evaluation as Hydrotest Equivalent

In this project, analysis was performed to demonstrate and validate the use of Guided Wave Ultrasonic Testing (GWUT) technology as an equivalent to a hydrotest.

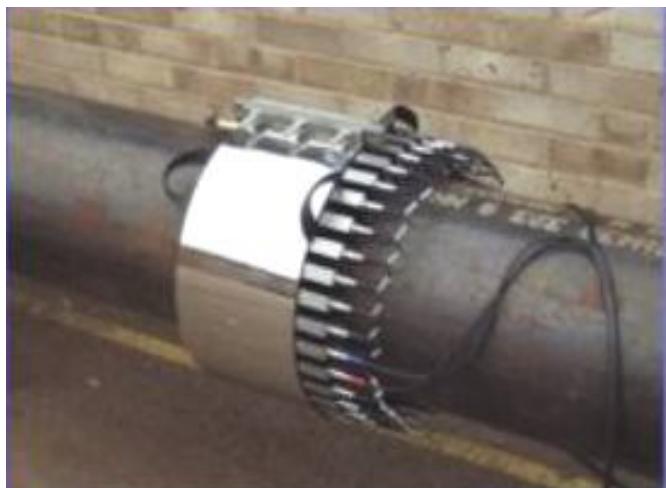
Collected data was used to calculate the failure pressure for rupture using several two-parameter methods

(depth/wall vs. axial length) for all validated data points. Additionally, the validation effort will determine the limits of detection and identification and provide suggestions for limits on field use and applications.

The percentage wall loss vs. anomaly length diagrams plotted to B31G confirmed that GWUT is equivalent to hydrotesting.

The GWUT methodology found all those anomalies that would have been found by the hydrostatic testing and GWUT also found anomalies that were too small to have been detected and survive in a hydrostatic test to a pressure equivalent to the pipe's Specified Minimum Yield Strength (SMYS).

All but two of the defects found by GWUT (and validated by excavation) would have passed a hydrotest to 100% SMYS by B31G.
